## Five-Year Review Summary Form

Site name (from WasteLAN): Silver Mountain Mine

**Third Five-Year Review of the Silver Mountain Mine Superfund Site,  
Okanogan County, Washington**

Brianne D. Harcourt, Site Manager  
Toxics Cleanup Program  
Washington State Department of Ecology

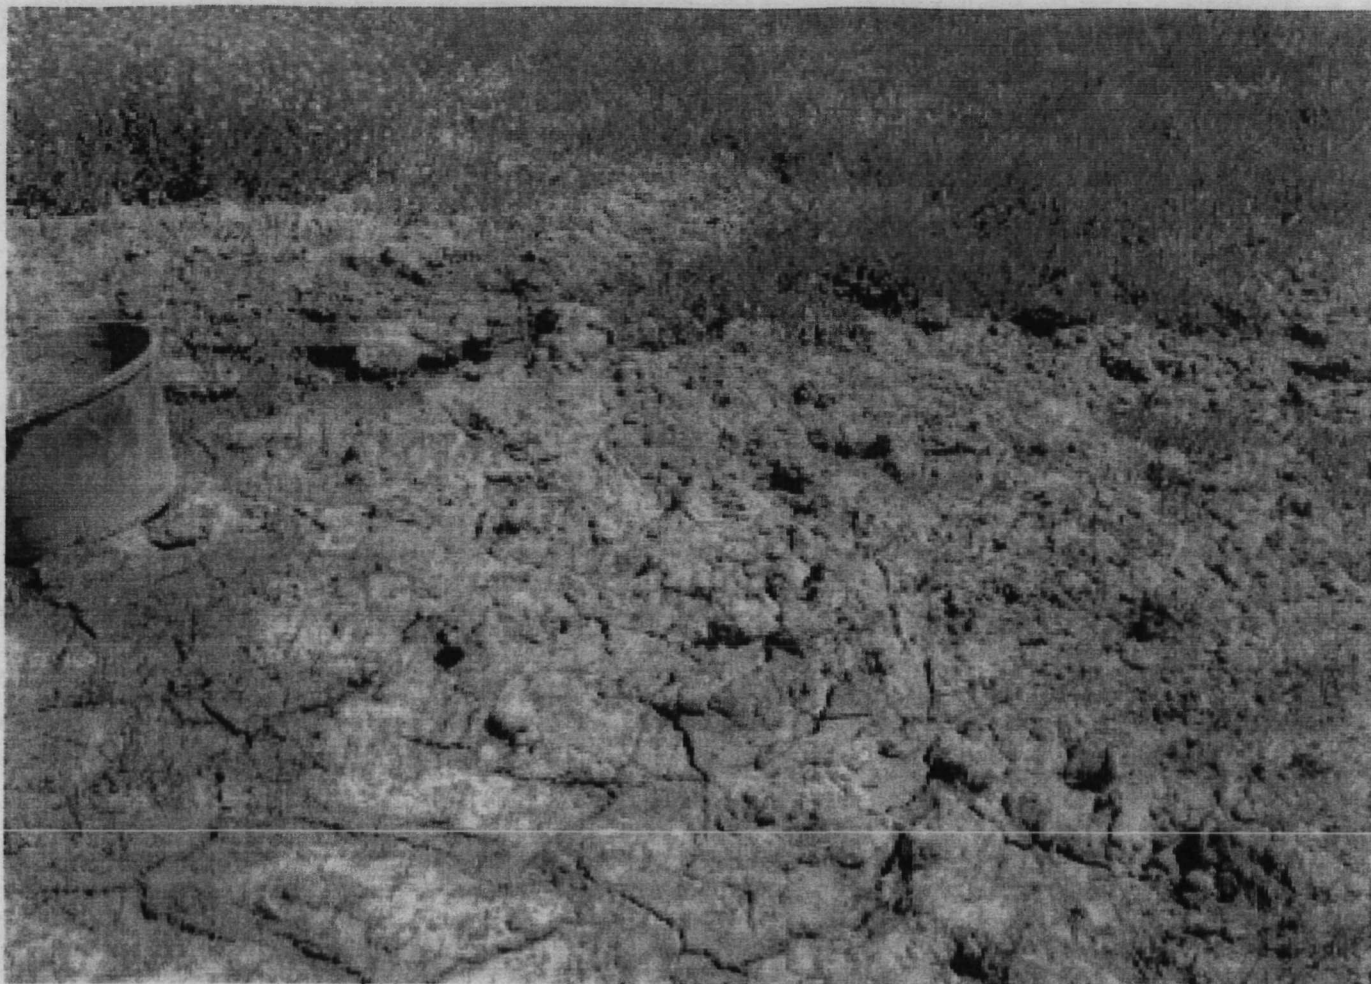
Adit seepage area

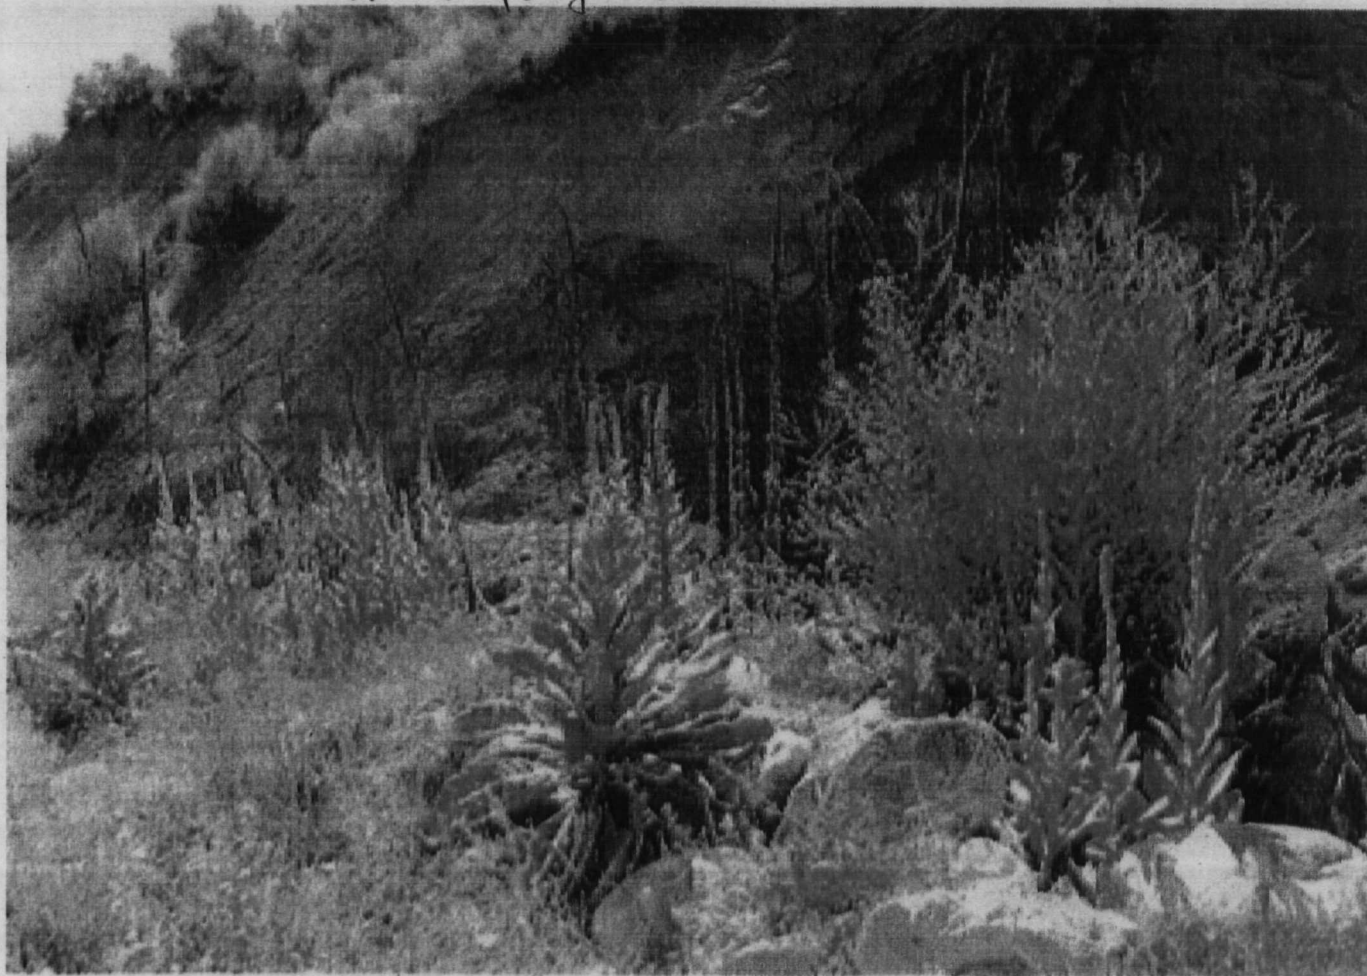
vegetation @ mine entrance

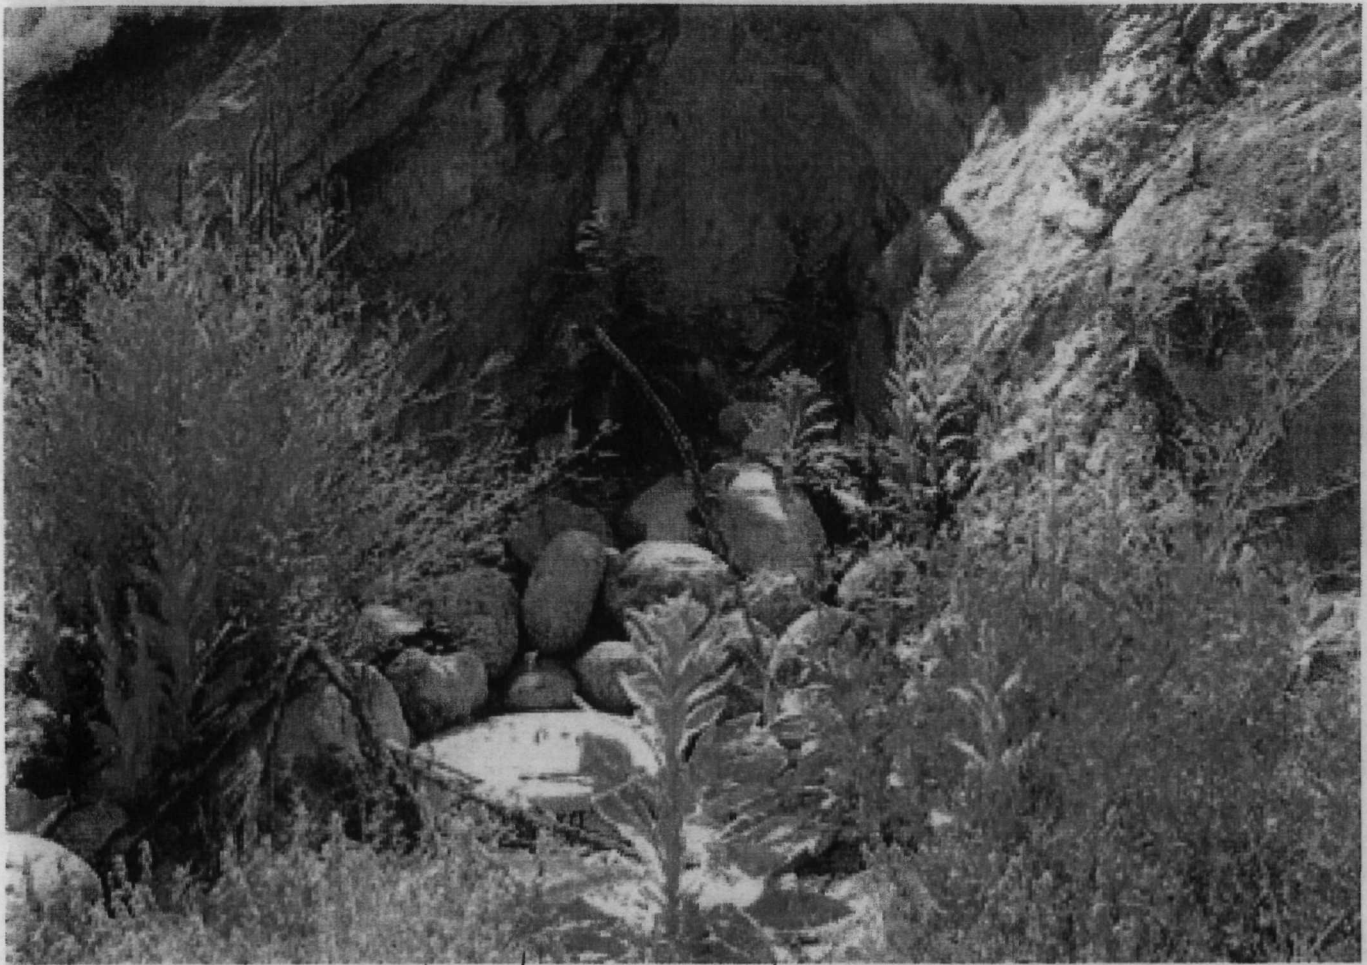
closed mine entrance

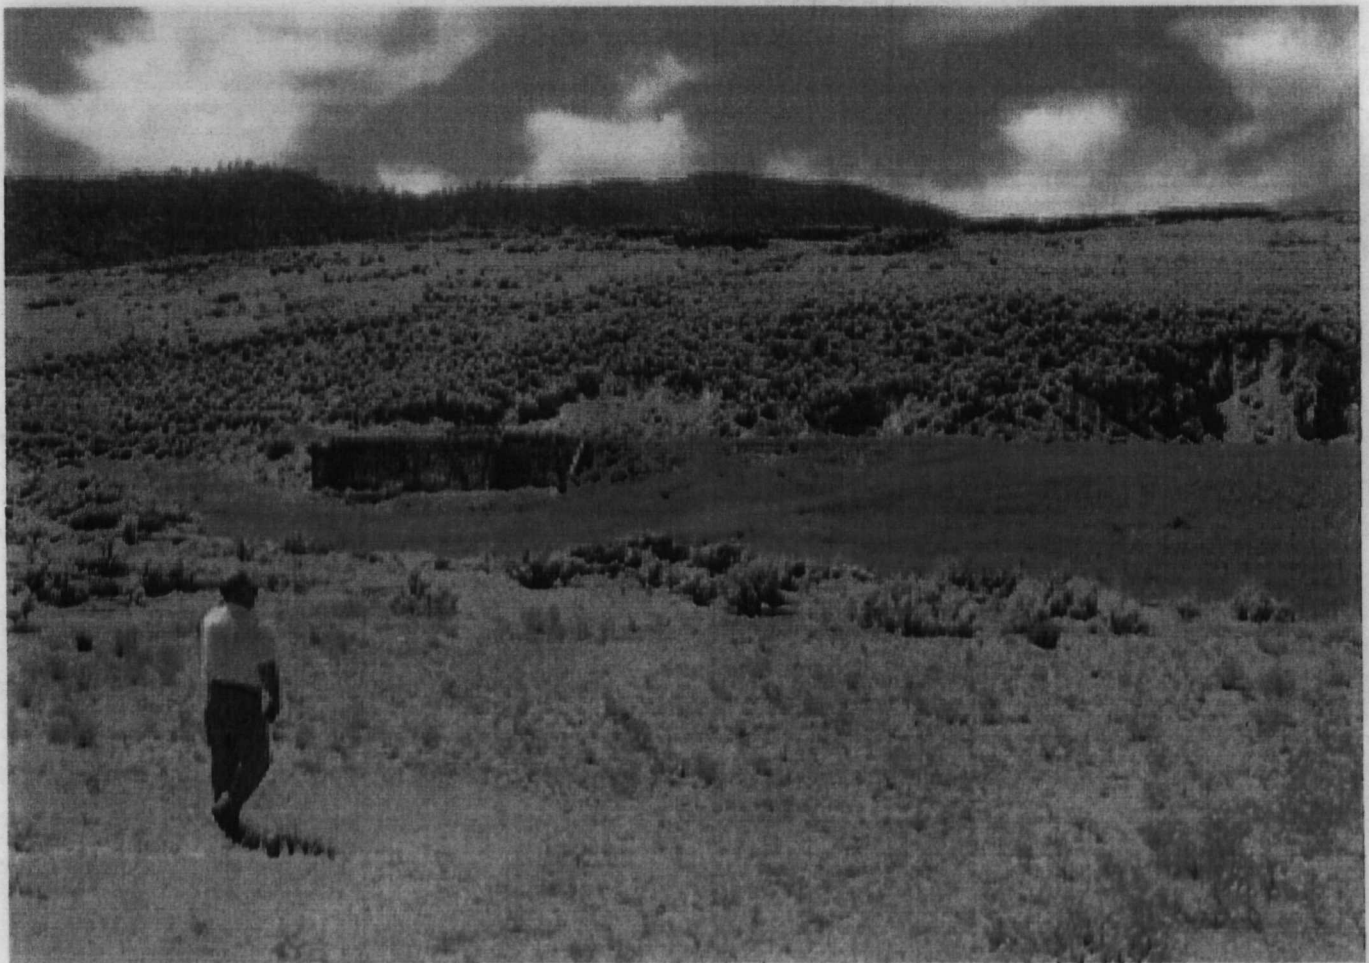
rapped heap leach pile & mill foundation

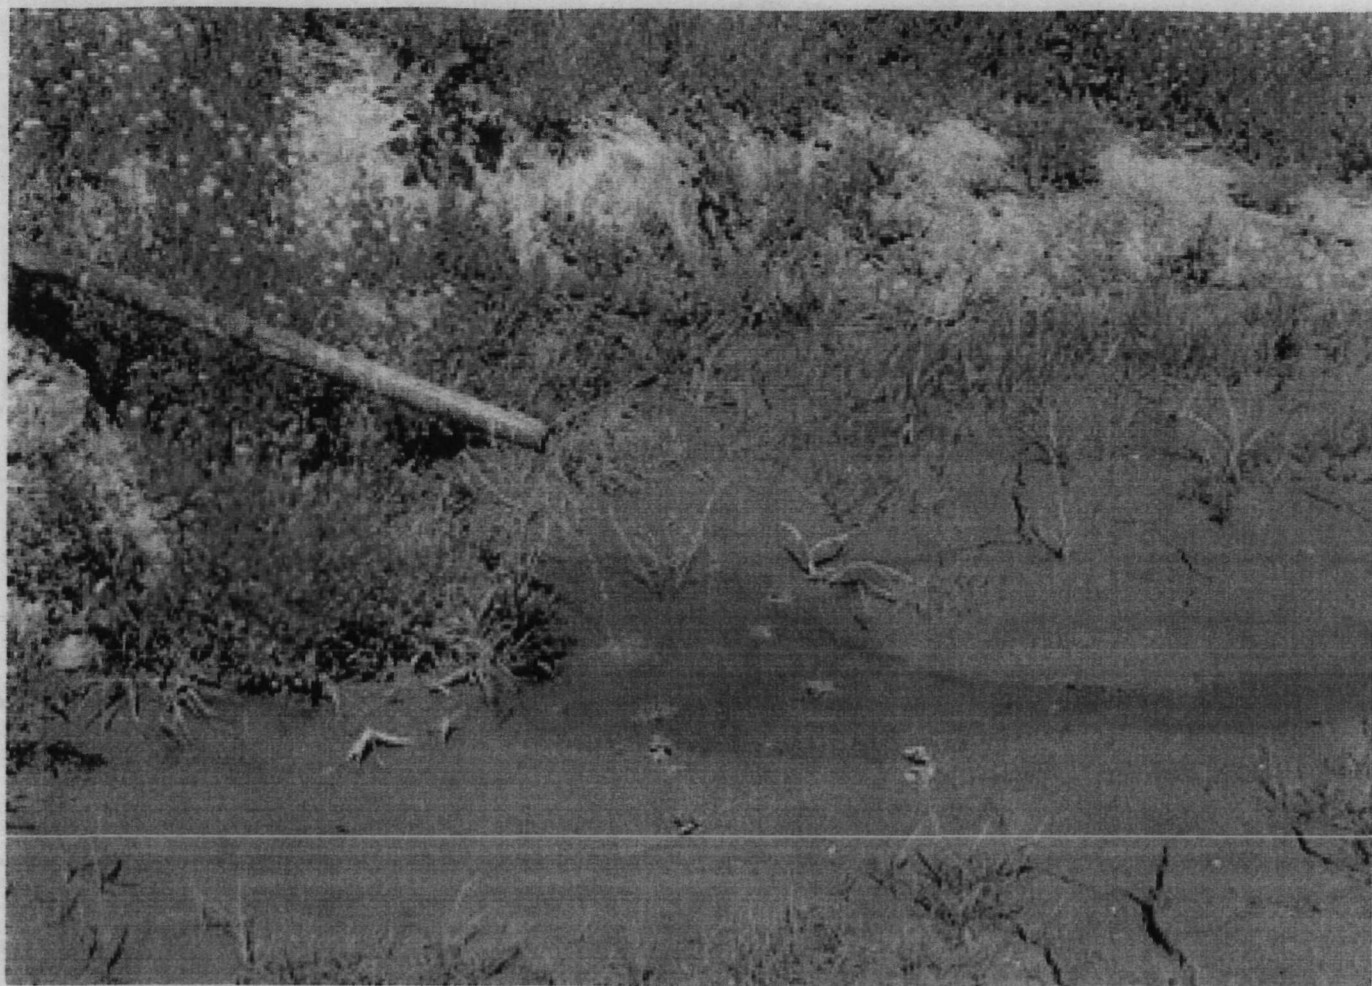
Following construction activities, surface water continued to enter the Site at a slow rate from a new seep coming from the blocked mine entrance. This flow was diverted away from the capped landfill area towards an area off-site and infiltrates into the ground before reaching the Site fence.

AdH seepage

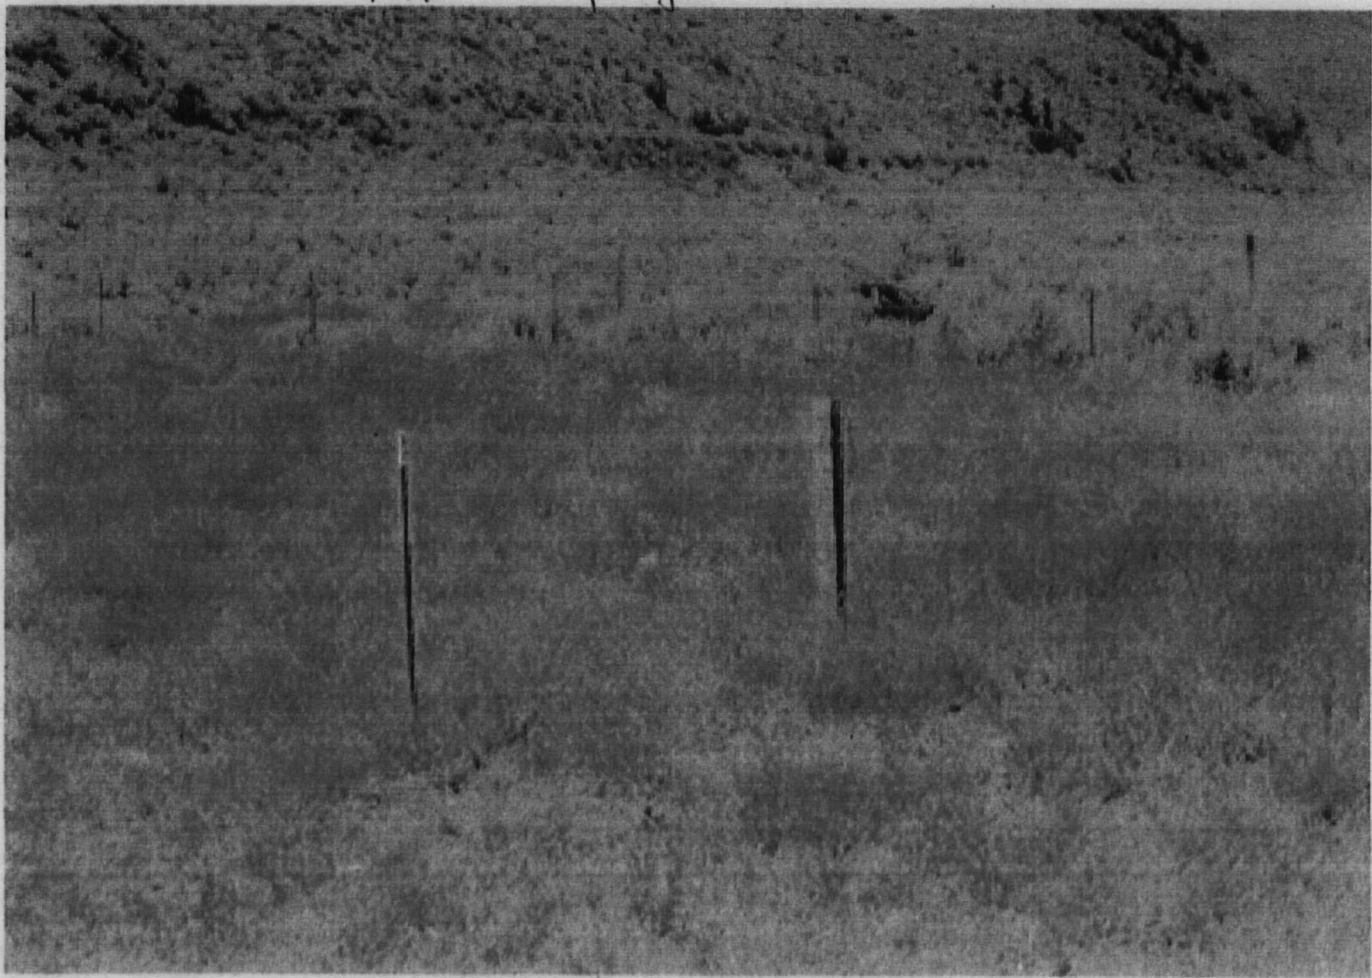
ACTIVITY	COMPLETED (Y/N)	REPAIRS PERFORMED (Explain)	COMMENTS
1) Inspect cap for:			
a) Subsidence	<u>Y</u>	None	None
b) Erosion	<u>Y</u>		None
2) Inspect cover for:			
a) Adequate vegetation	<u>Y</u>	None	Eriass coverage on the cover is very good - and vegetation is consistent w/ surrounding vegetation. Very minimal woody vegetation present.
b) Weeds	<u>Y</u>		
c) Holes	<u>Y</u>		
d) Minimal woody vegetation on cap cover	<u>Y</u>		
3) Inspect fence	<u>Y</u>	None	Interior (EPA) fence damaged, exterior fence prevents access to site

Disturbed fence

Conduct annual inspections and maintenance of the cap to ensure continued protection of human health and the environment at the Silver Mountain Mine (Site). The EPA fence is in disrepair; however, a newer fence placed by the adjacent property owner adequately controls access to the Site. The fence situation should continue to be monitored on an annual basis to ensure that it is protective of the remedy.

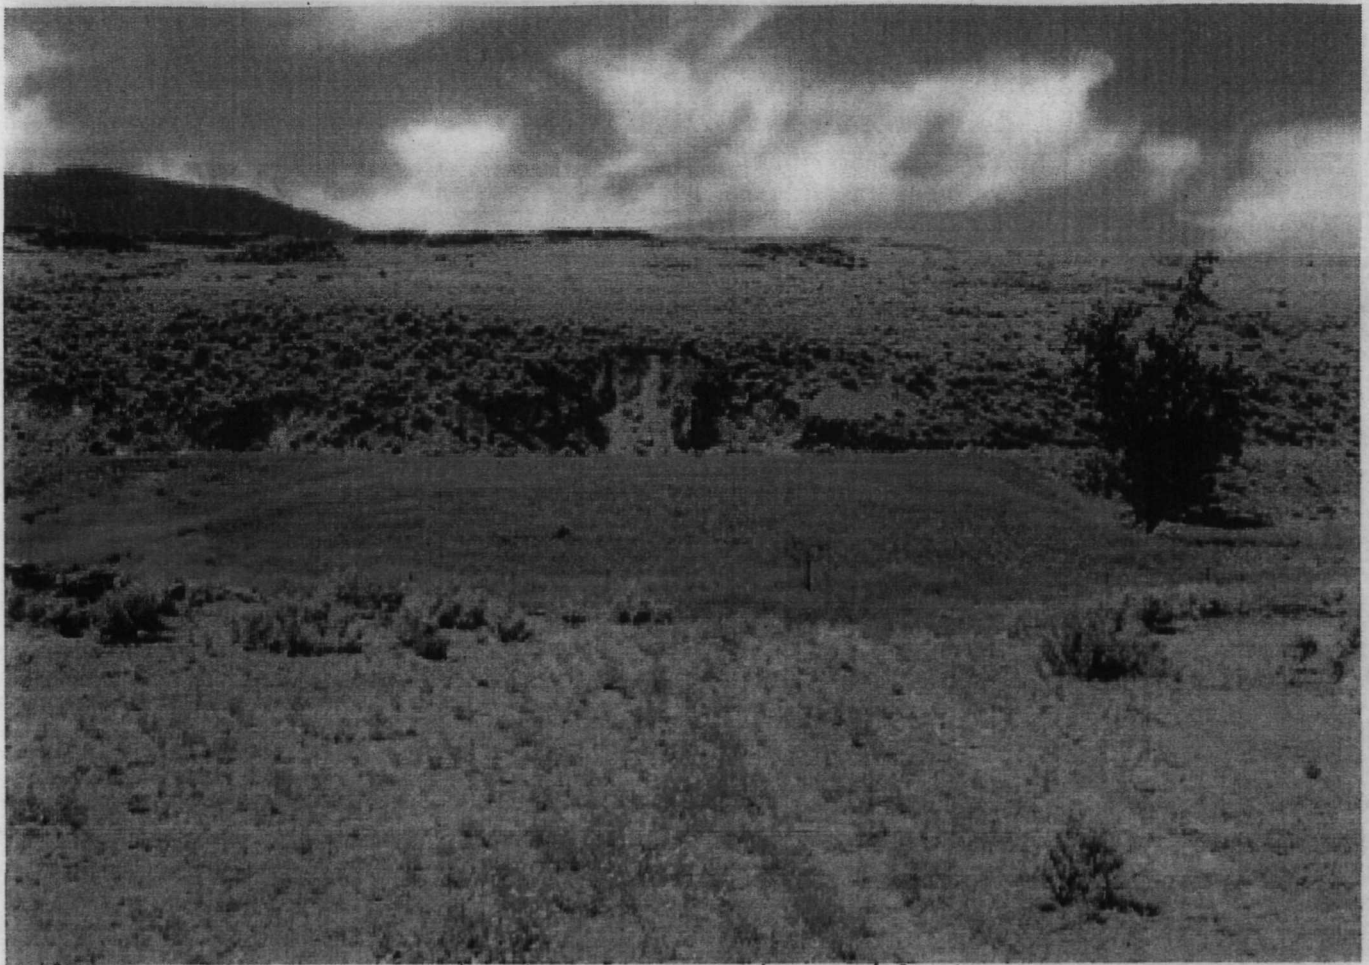
capped heap leach pile

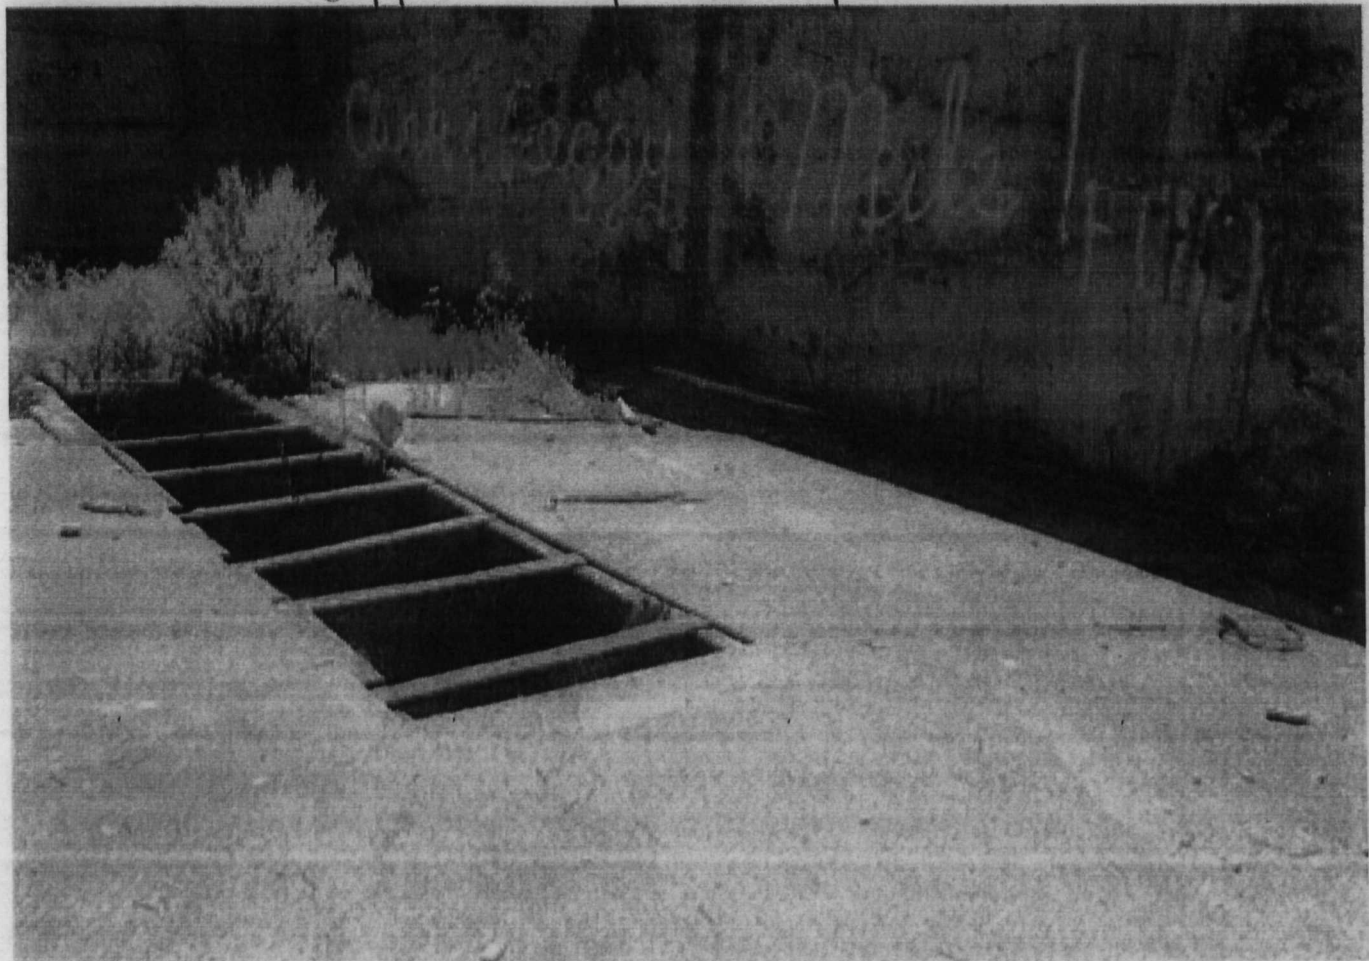
mill foundation

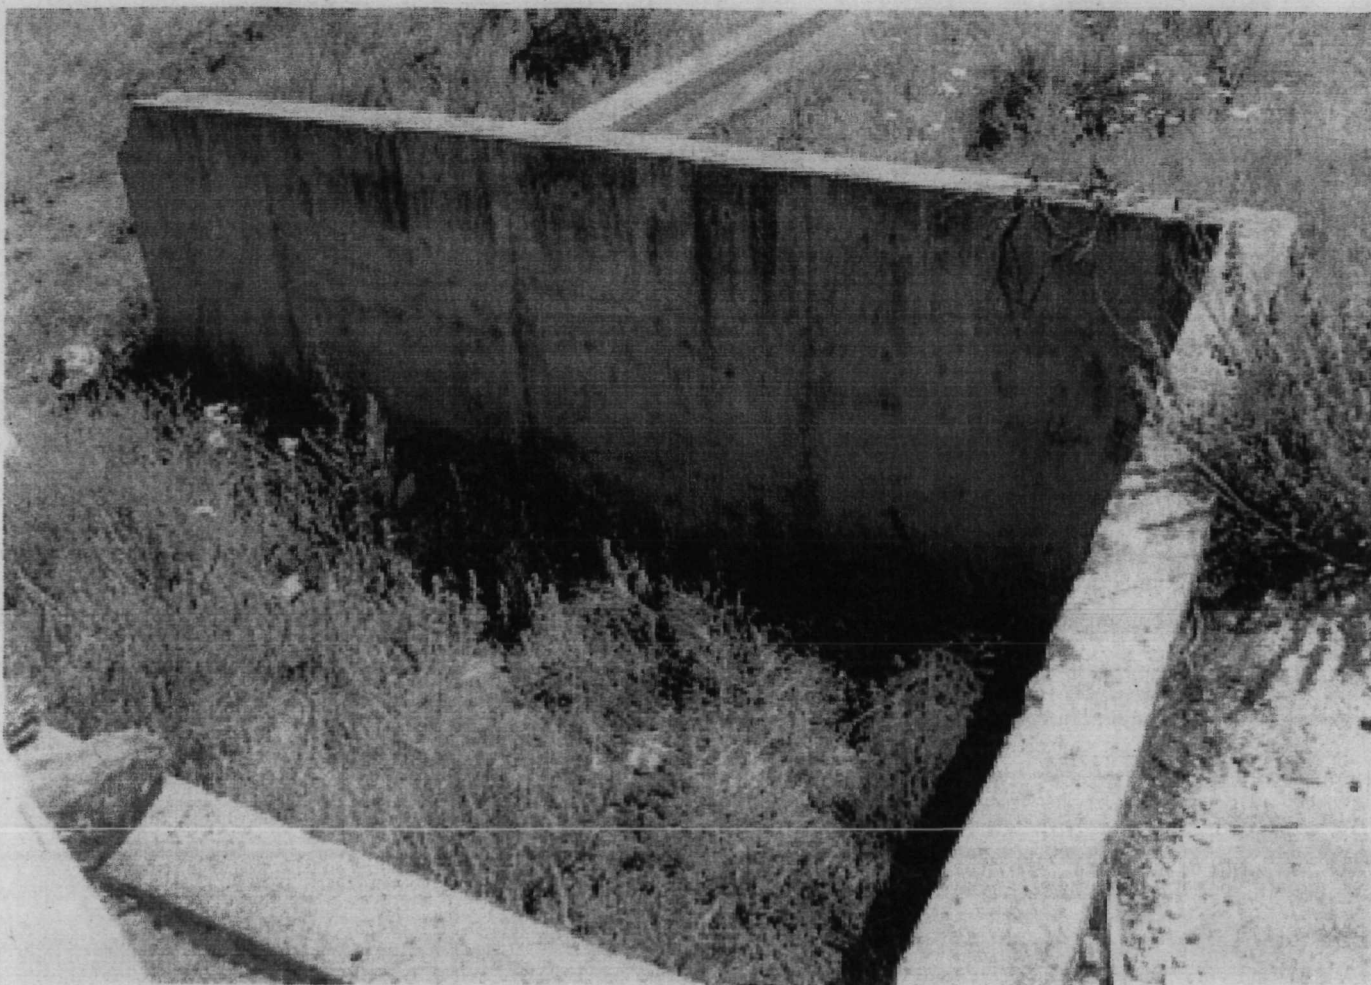
mill foundation

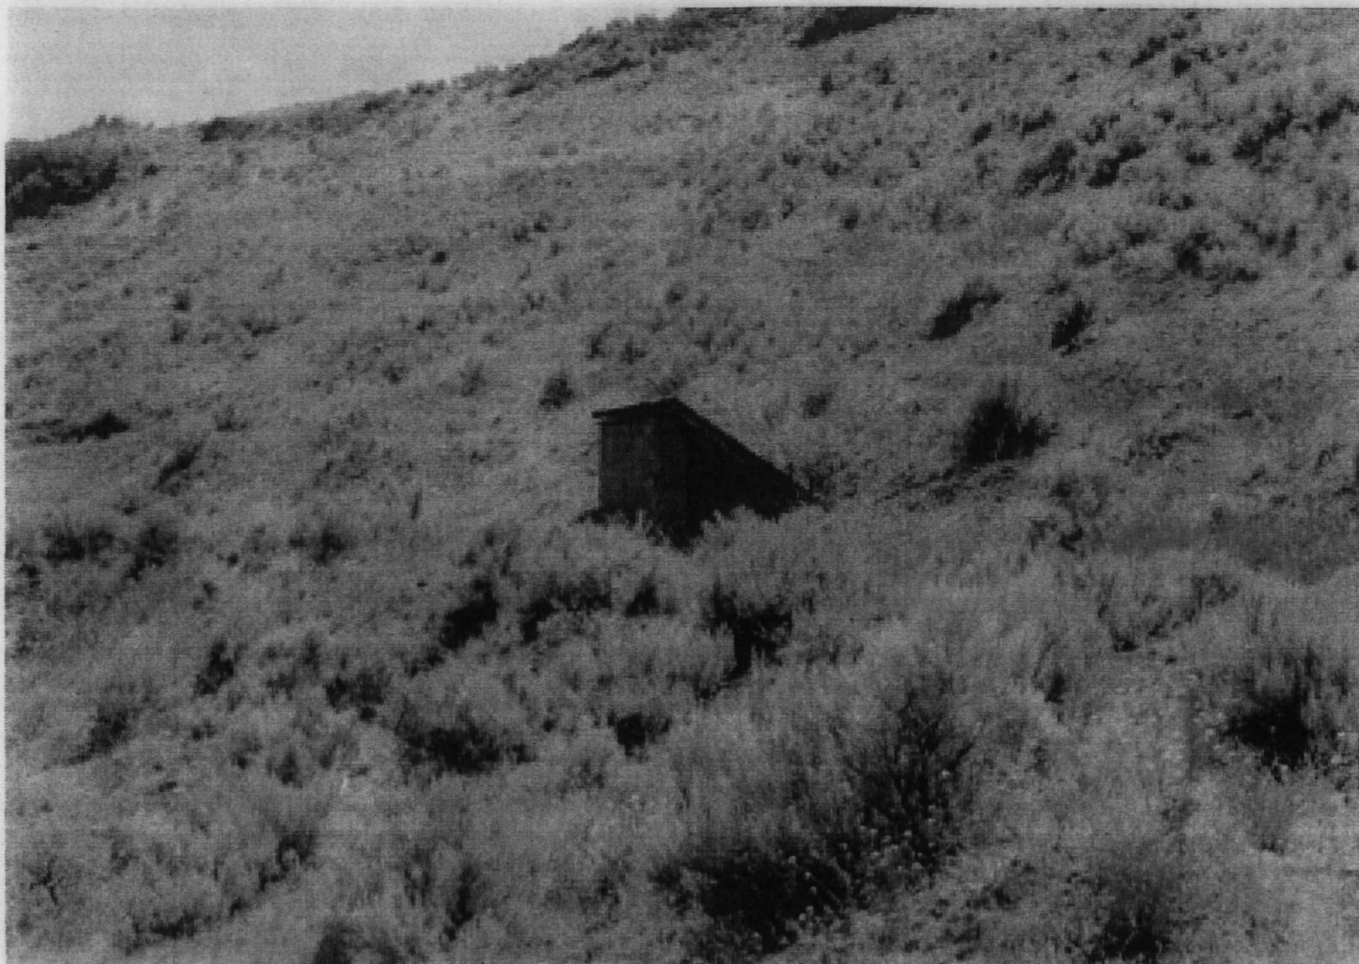
old mine structure

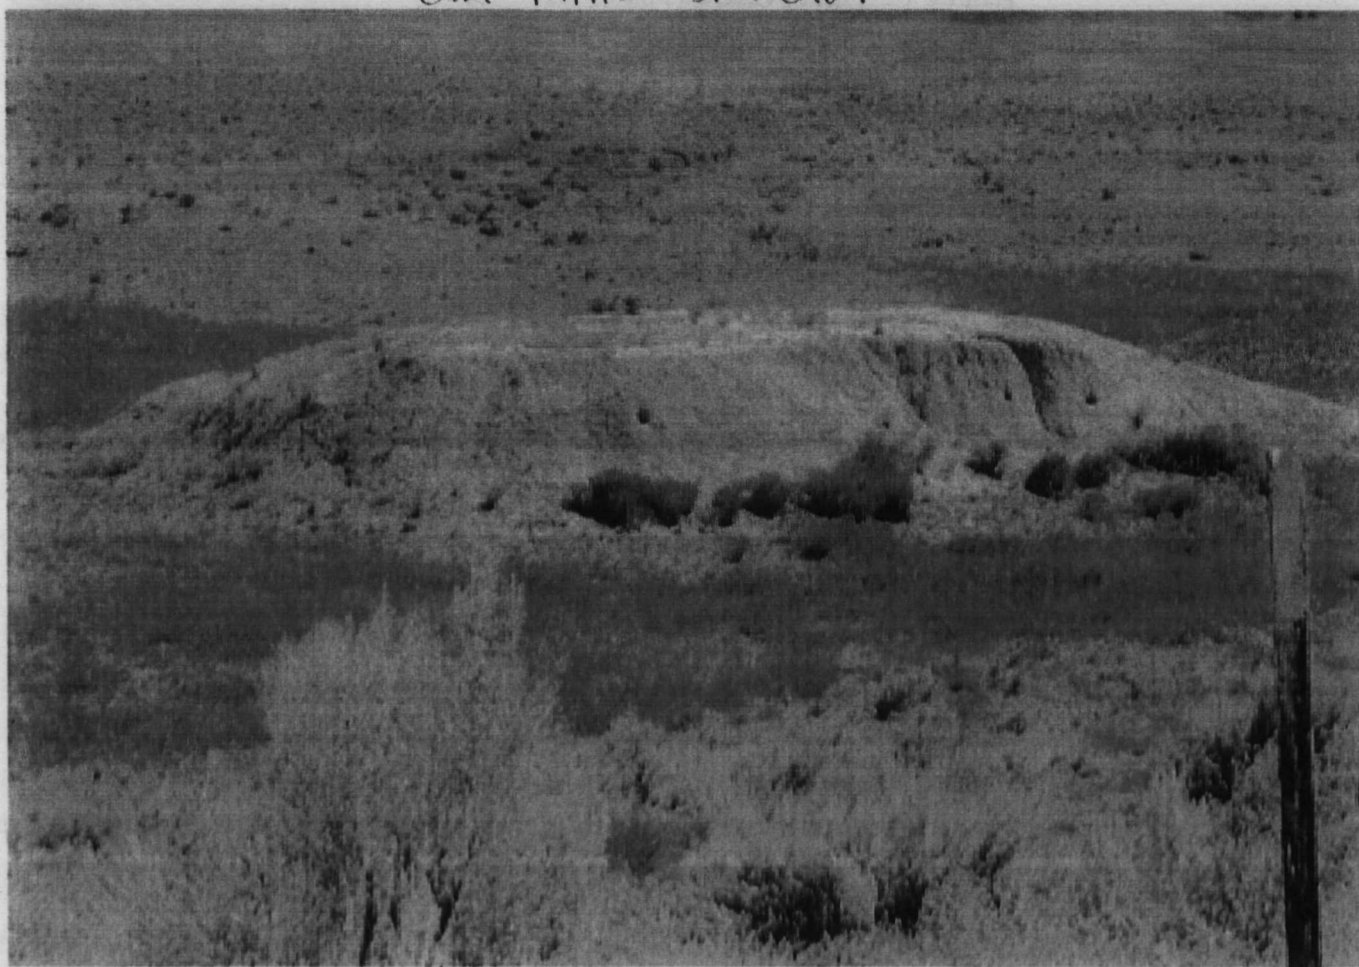
stockpiled clay from construction activities

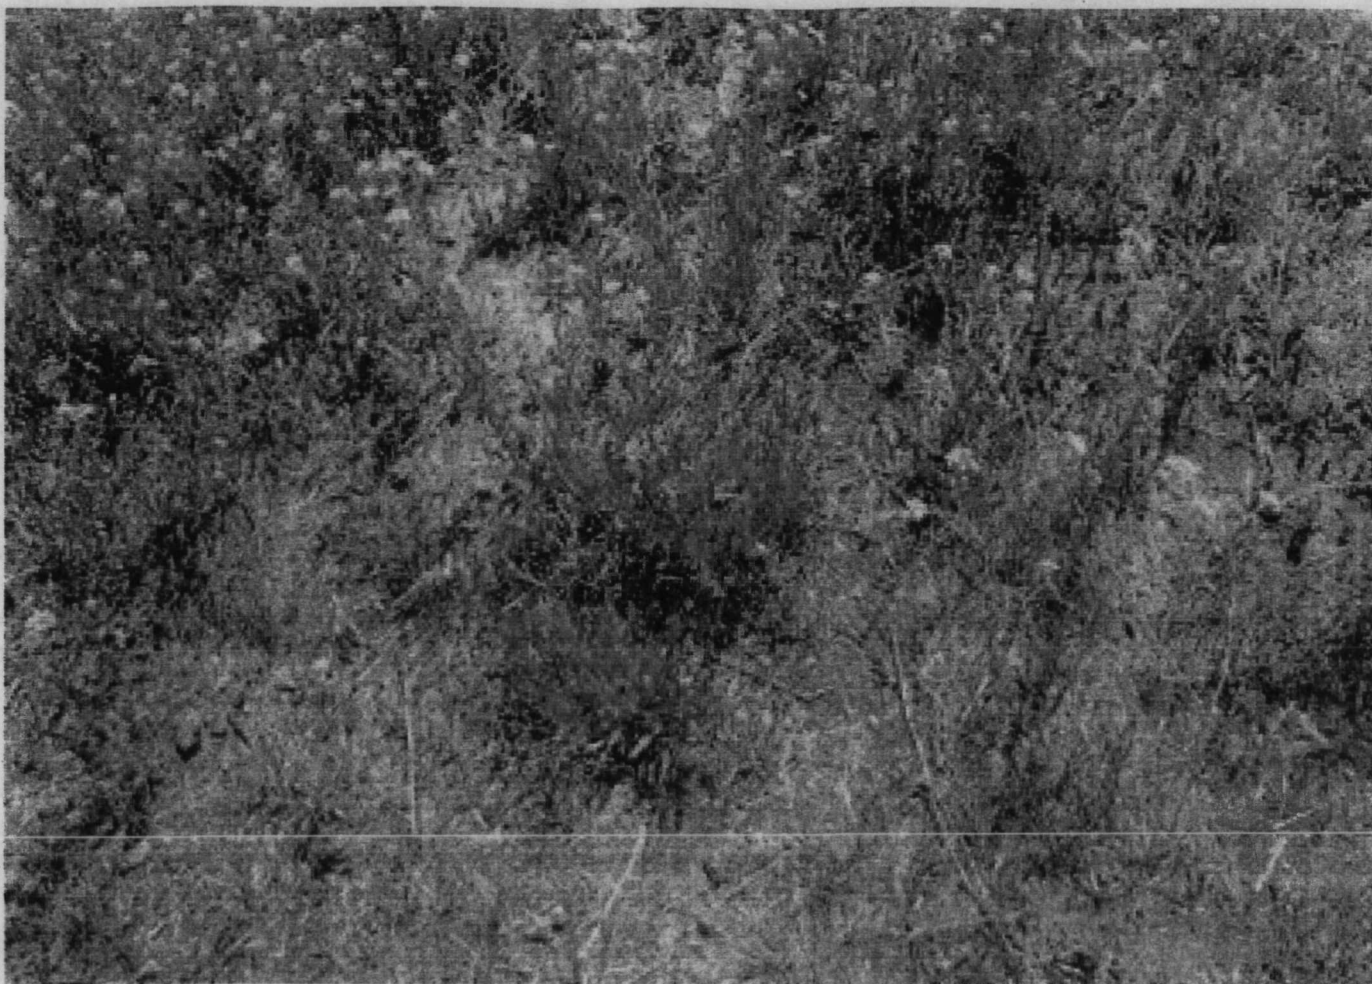
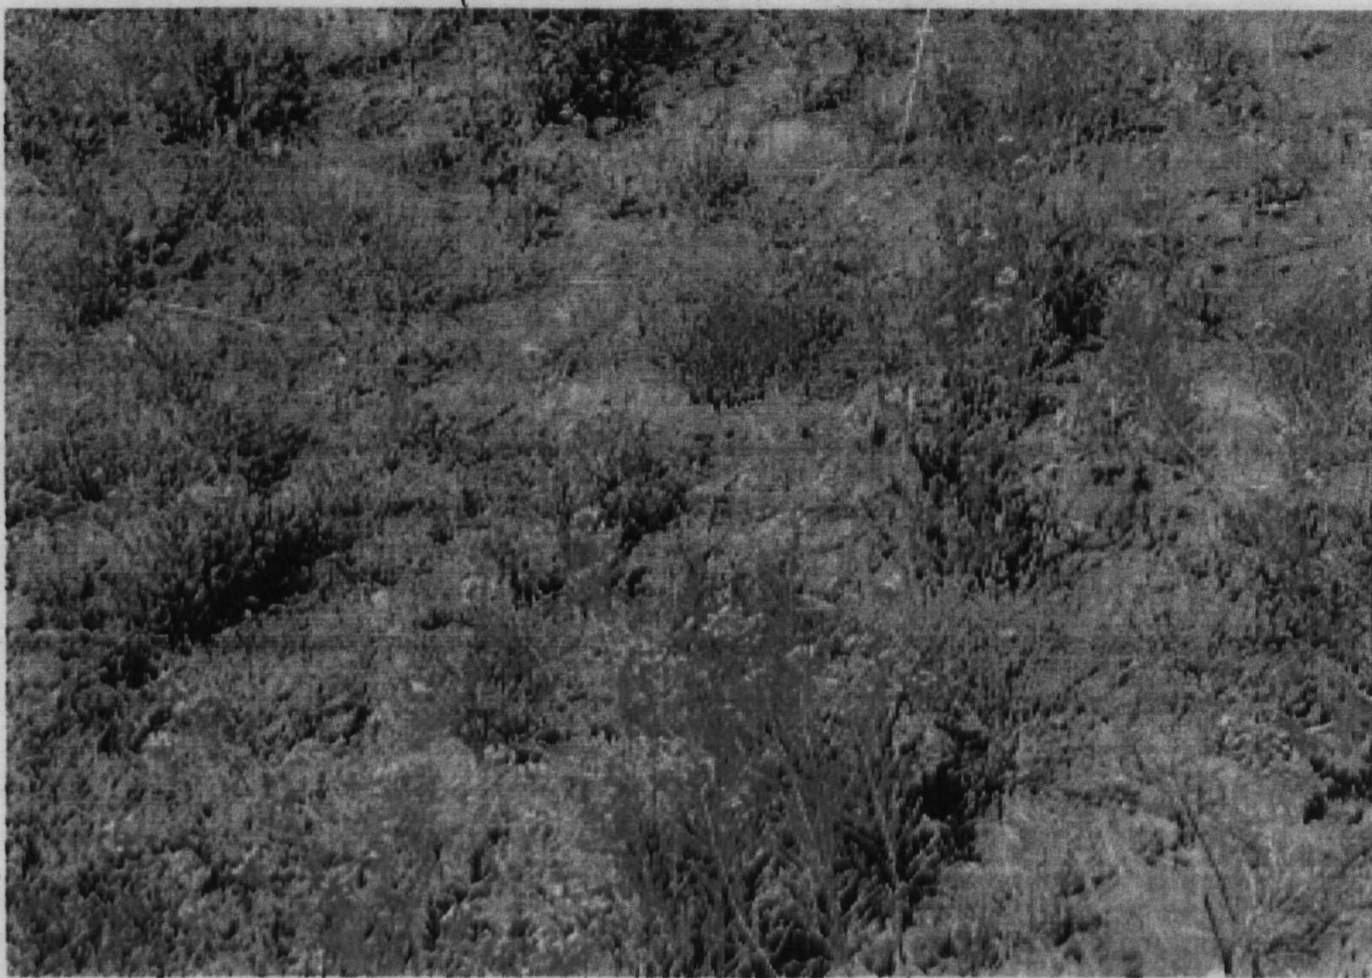
vegetation on cover

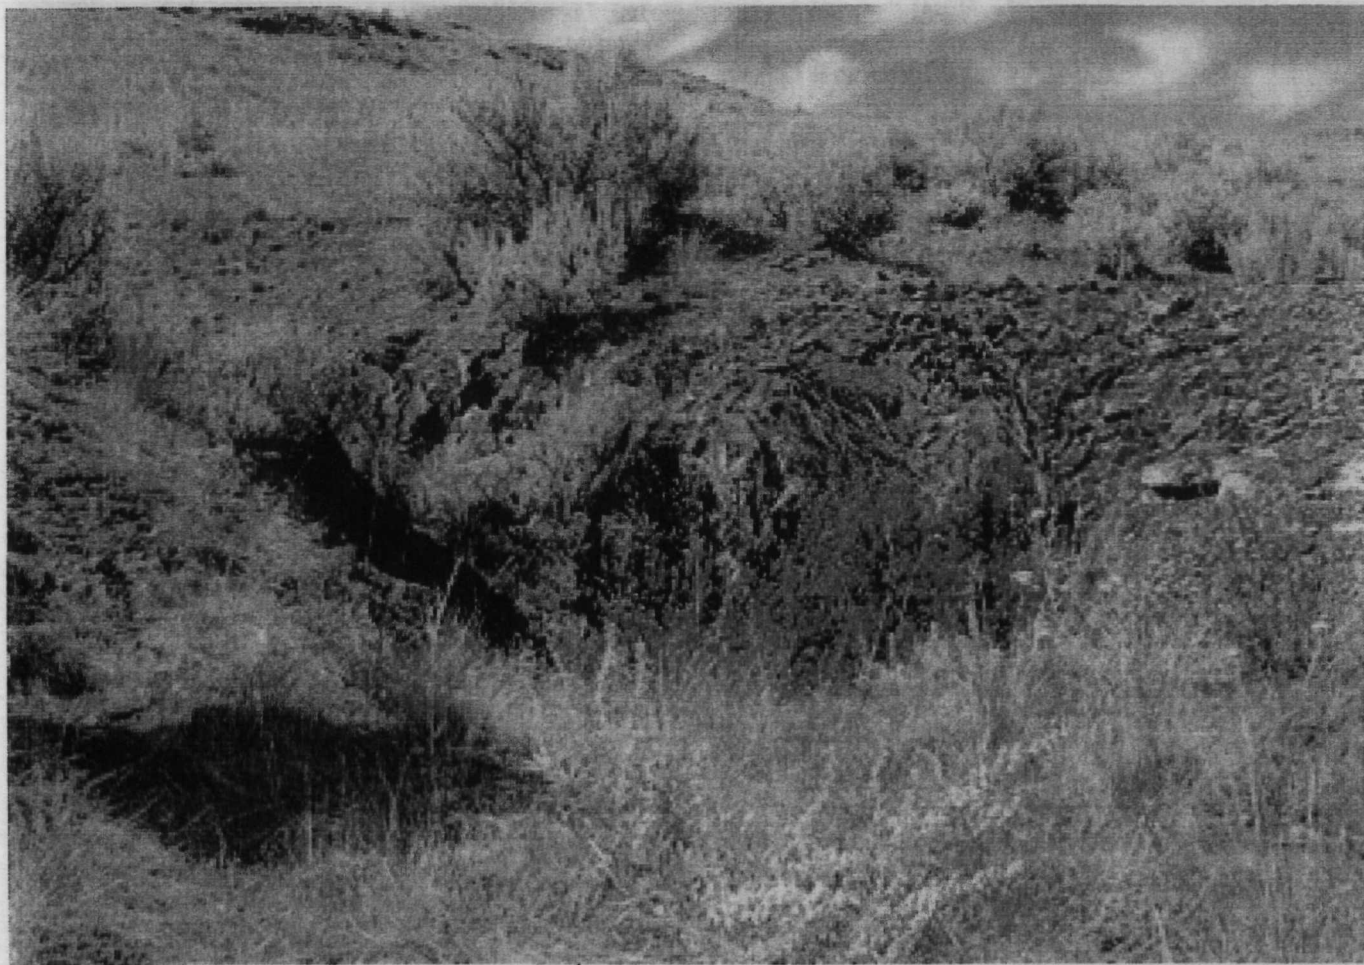
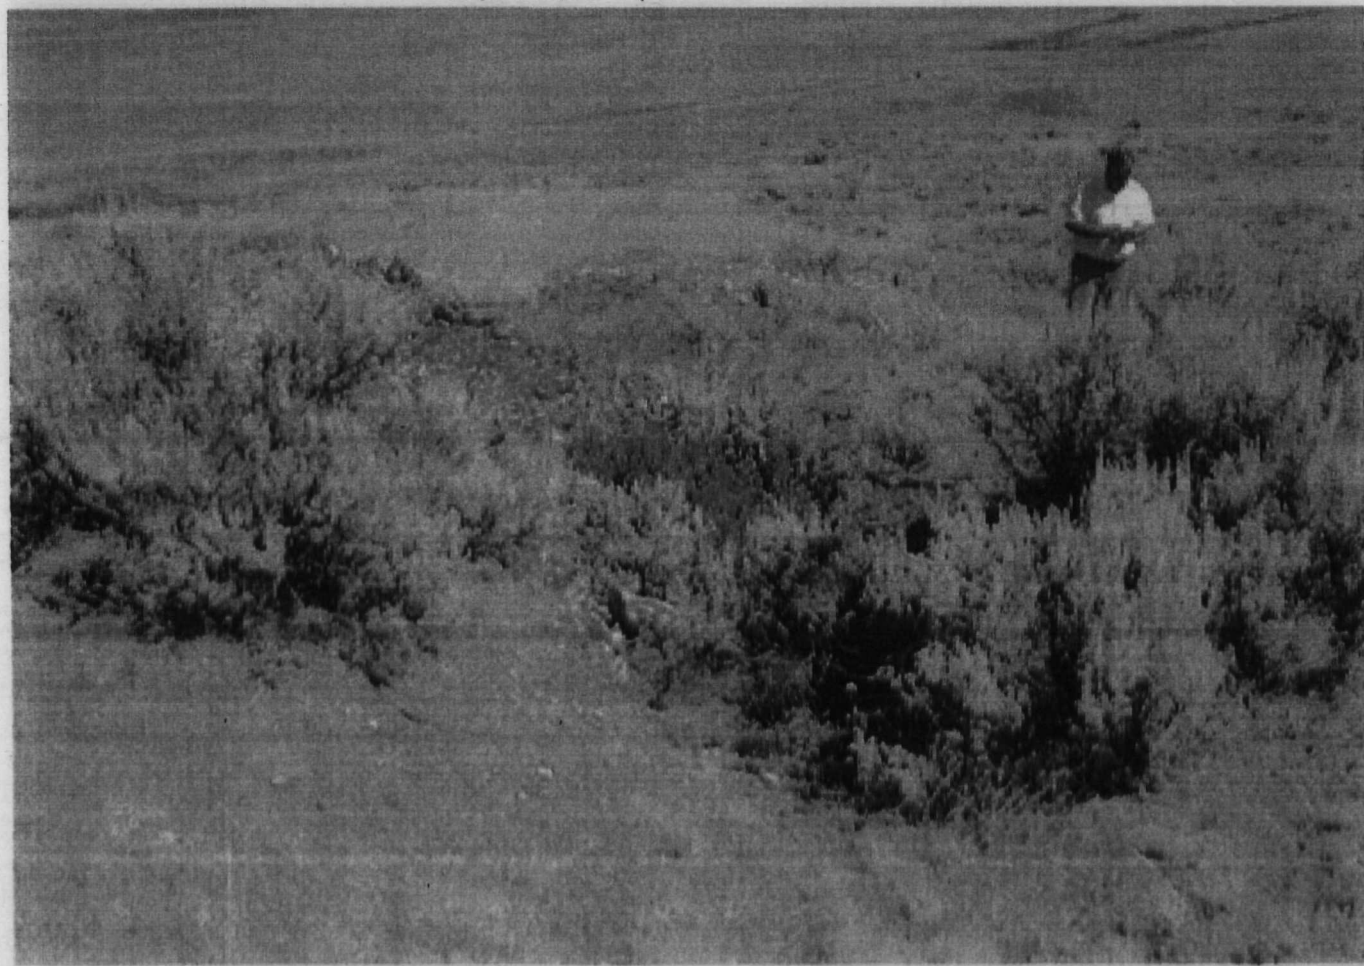
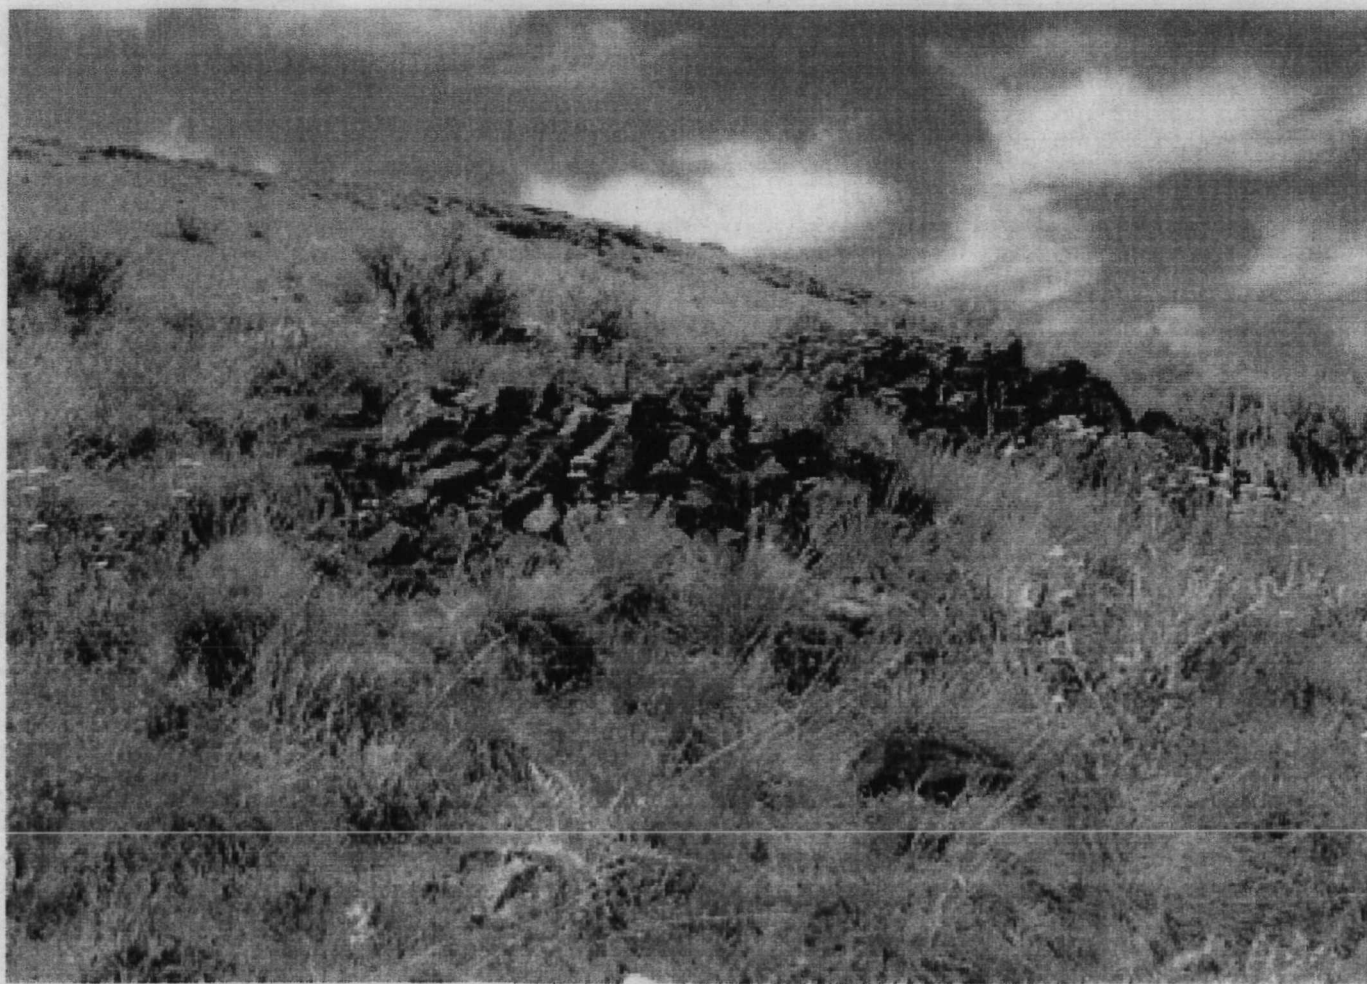
closed mine vent
